Fairview - AS 4284 testing on facades

Test Report - Vitracore G2 with Flexible Membrane

30B-19-0059-TRP-6774694-1

11 November 2020

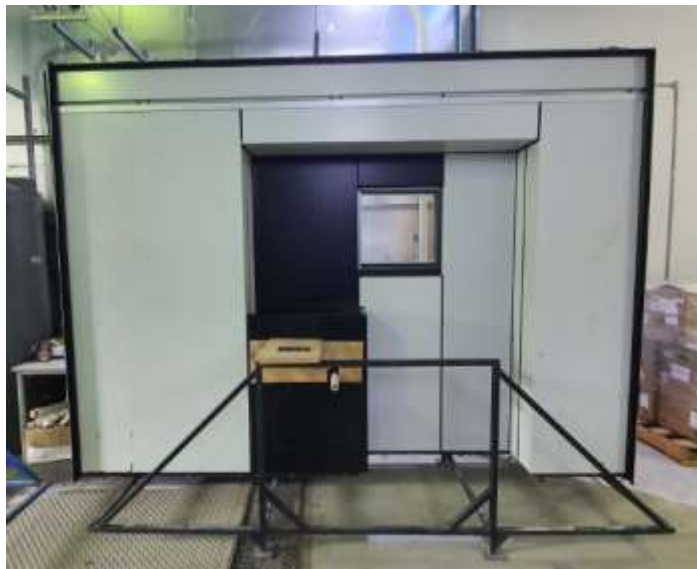
Figure 1: Cladding sample after removal

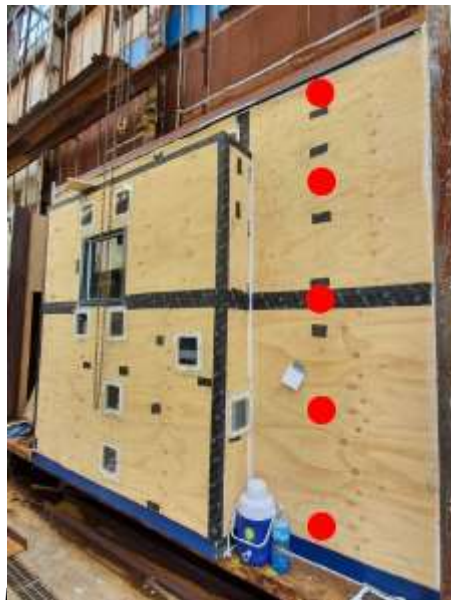
Figure 2: Node locations (1-5 from bottom to top)

Conclusion: The test sampled complied with the structural span deflections limits of Span/250. The sample did not comply with the residual deflection limit of 3mm
